# **ITRI Project on Electroless Nickel / Immersion Gold Joint Cracking**

F.D.Bruce Houghton  
Celestica, Inc.  
North York, Ontario, Canada

## **Abstract**

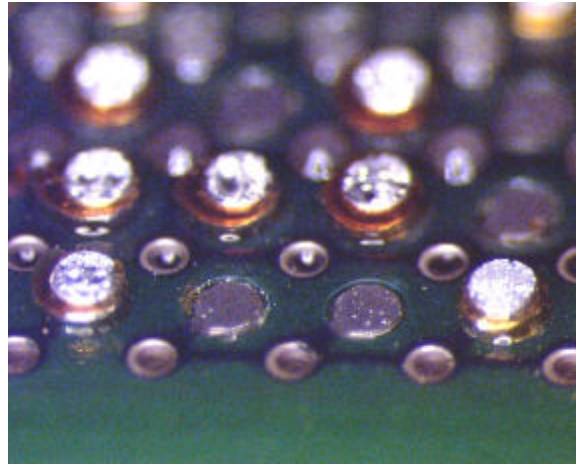
**Figure 2 - Type #3 (shiny) and #5 (Gray) Fails**

#3 Solder to Ni shear at component side

#5 Solder to Ni shear at board side

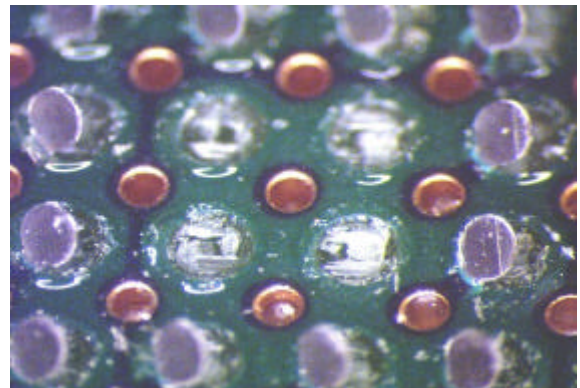
**Figure 3 - Type #7 Ripped and #8 Lifted Pads**

#7 Rip Cu pad off board side

#8 Lifted Cu pad from board side

The 4 corner pads and 4 center pads that were isolated from all other circuits and with no trace to the adjacent via land often ripped totally off the board. The remaining 92 pads with traces to the adjacent via land usually would be ripped from the FR4 on good joints, but still held by the trace. The pad would be left standing up on end. Occasionally on a good joint, some of these pads would get ripped off the board as well.
