# Solving the ENIG Black Pad Problem: An ITRI Report on Round 2

F.D.Bruce Houghton  
Celestica, Inc.  
North York, Ontario, Canada

## Abstract

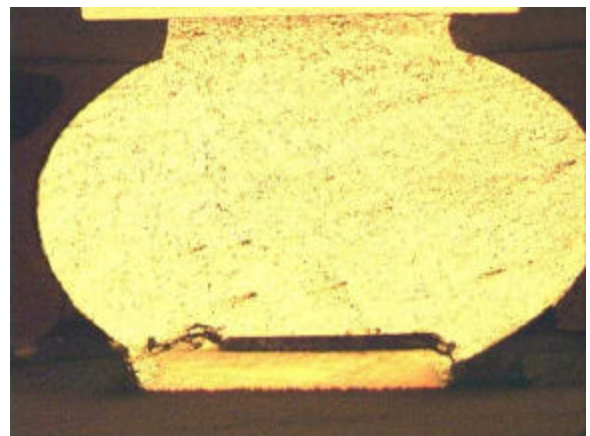
**Figure 1- BGA Ball with Cracked Ball Joint**

Figure 1 shows a cross section of a BGA solder joint with a crack along most of the nickel interface.

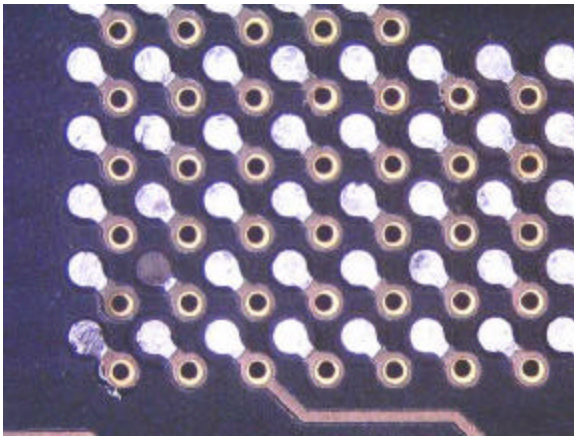
**Figure 2 – BGA Site with One Black Pad**

Figure 2 shows a BGA site after a component has been removed and the excess solder wicked off the pads. One pad is very dark to black in appearance.

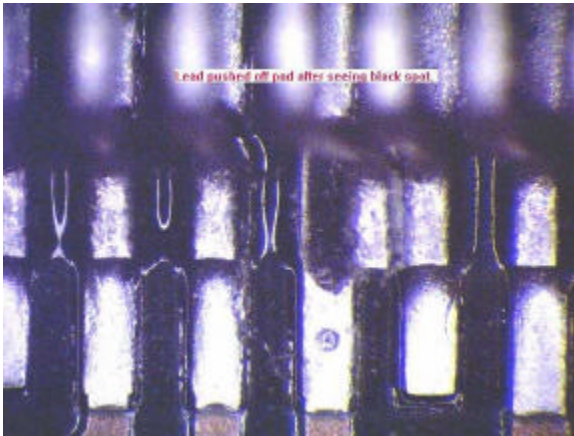
**Figure 3 – QFP with Cracked and Shifted Lead**

Figure 3 shows a group of QFP leads with one lead pushed to one side. The solder has lifted off the pad along the nickel interface and remains adhered to the QFP lead.

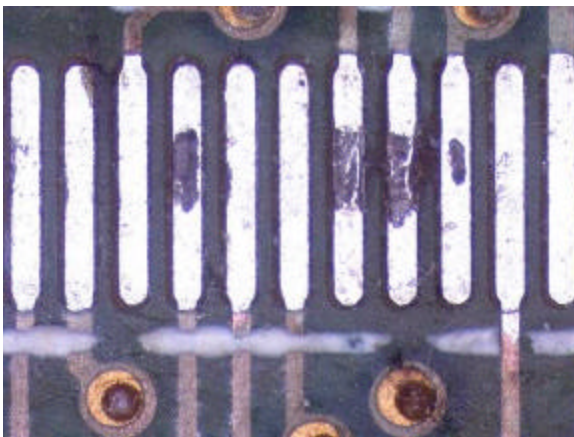
**Figure 4 – QFP Black Pads after Solder Wick**

Figure 4 shows a QFP site after the component has been removed and the excess solder wicked off the pads. Three pads have varying degrees of a black pad appearance.

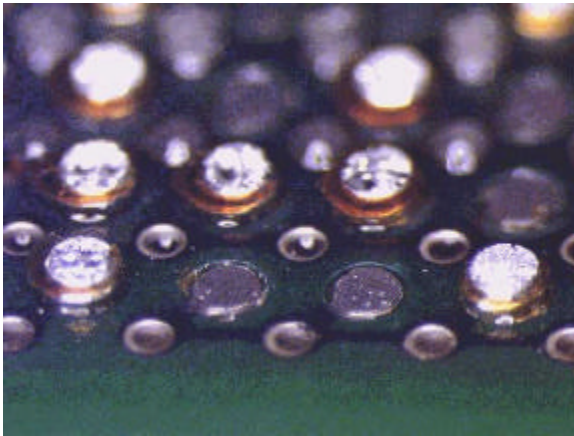
**Figure 11 – Instron Bad Pull Result**

If the nickel to solder bond is a problem, then the failure could occur at either interface #3 or #5. The solder would separate from either of these surfaces, leaving the pad still attached to the FR4 and a potentially 'black pad' on the nickel surface. Fractures at either of these surfaces was considered a bad failure mode in Round 1 and likewise for Round 2.

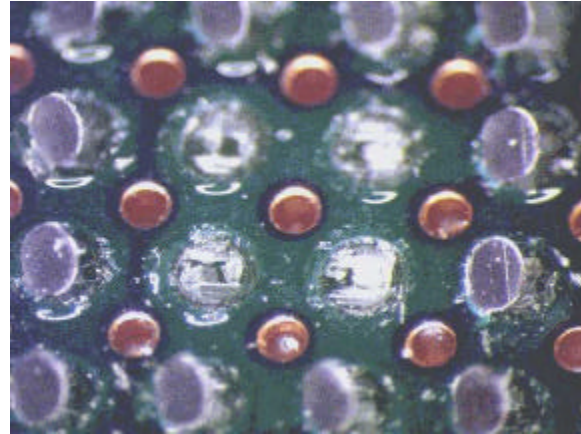
**Figure 12 – Instron Good Pull Result**

If all of the solder joints between nickel and bulk solder are solid joints, then the failures should all occur at the board BGA copper pad to FR4 with either the pad lifting at interface #7, or being totally ripped off the board at interface #8.
