Failure mechanisms in ceramic capacitors

Design and process issues

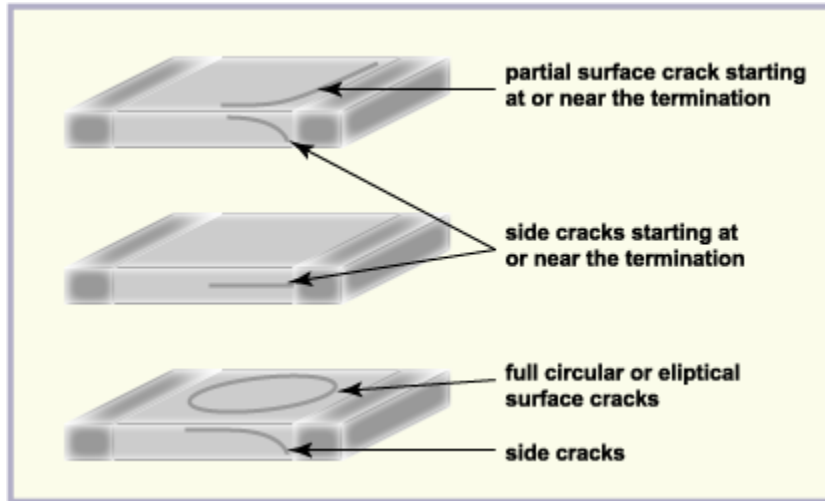
Figure 1: Extreme thermal shock cracks in MLCs

The solder terminations also expand at a greater rate (25–30 ppm/°C) than the ceramic part and exert an annular tensile force on the edges of the component. In severe cases, when a large surface mounted capacitor has been subjected to a sudden thermal shock, a clearly visible elliptical crack may form on the upper surface of the chip (Figure 1). This is primarily due to the tensile forces exerted by the terminations.

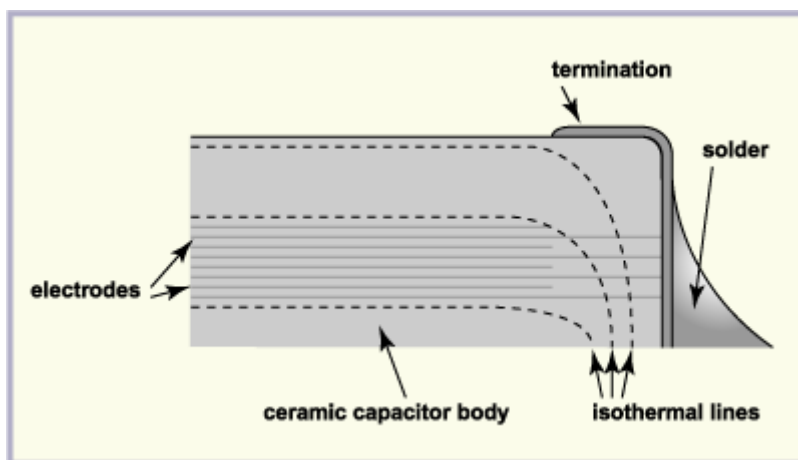
Figure 2: Micro-cracking under thermal stress

Less obvious is the creation of micro-cracks under the visible surface of the capacitor, which propagate along isothermal lines within the component (Figure 2). This form of damage is particularly insidious, since electrical failure may not occur until some time after assembly, when the finished product is out in the field.

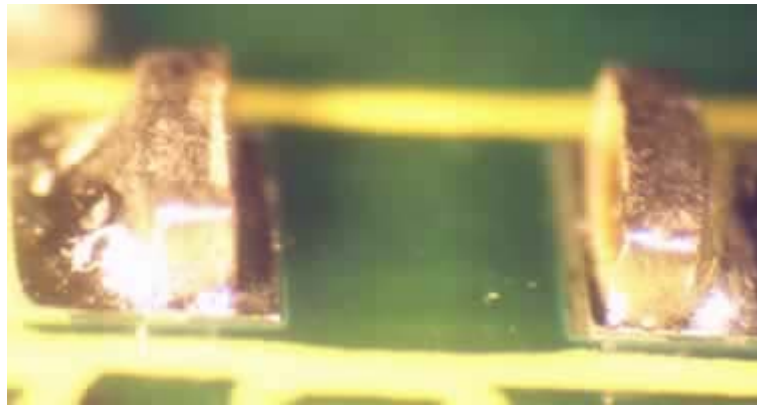
Capacitor missing after severe cracking

After a number of temperature excursions, for example due to circuit operation, the crack may propagate (Figure 3), creating an open-circuit device. In severe cases, the body of the capacitor may even fall out, leaving just remnants of ceramic surrounded by termination and solder joints.

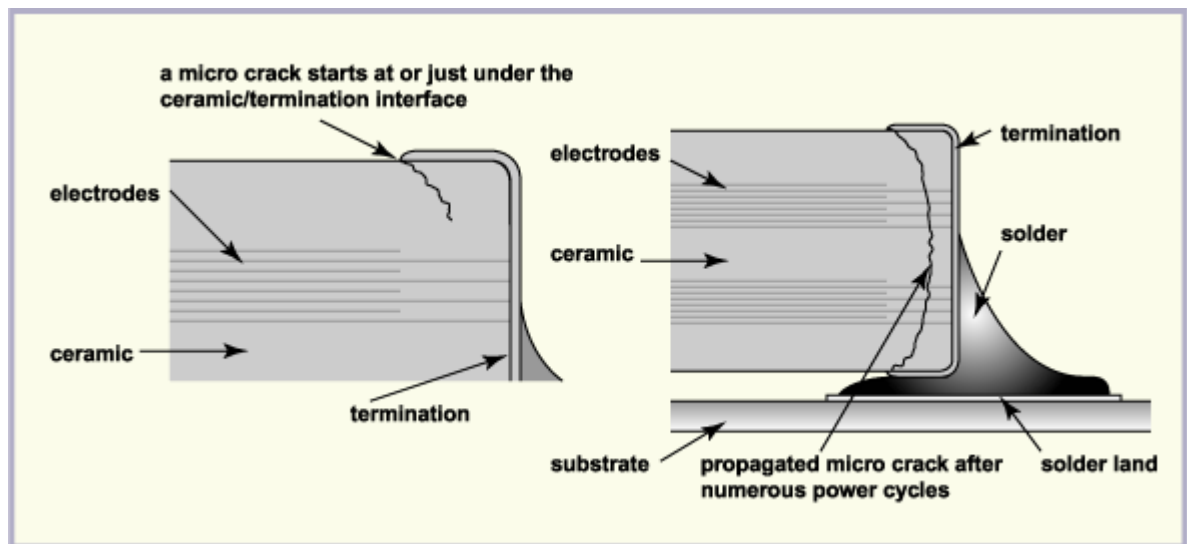
Figure 3: Propagation of a micro-crack

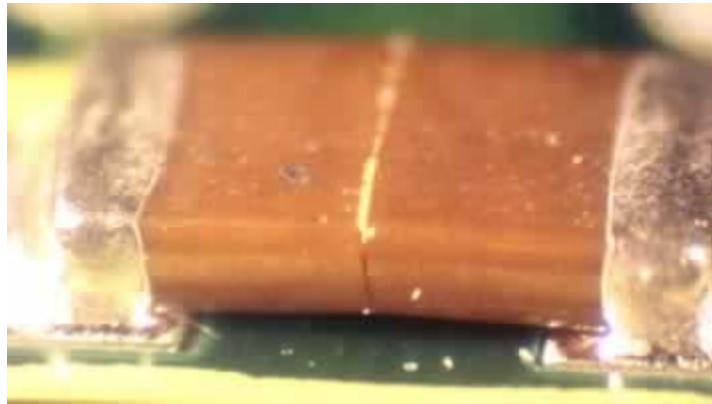
Cracked capacitor

When a circuit board is bent, its shape tries to become an arc of a circle, as far as the rigidity of the attached components will allow. The outer surface stretches and the distance between the component lands is increased, placing the chip under tension: conversely, on the inner surface, an MLC is exposed to compressive strain. Whilst any joint will stress-relieve, given time, in the short term only a limited degree of stress reduction can come from deformation of the solder joint. If the forces applied to the chip exceed its breaking strength, the chip will crack!

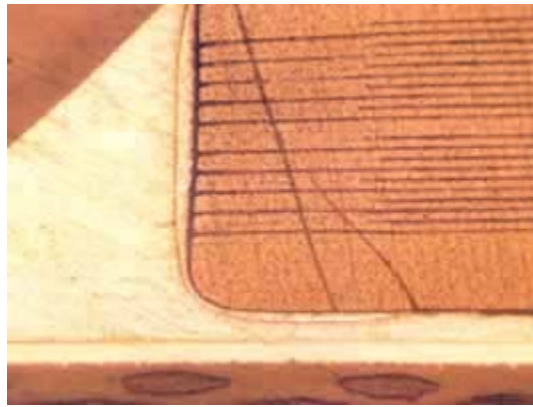
Bending-induced cracks in an MLC

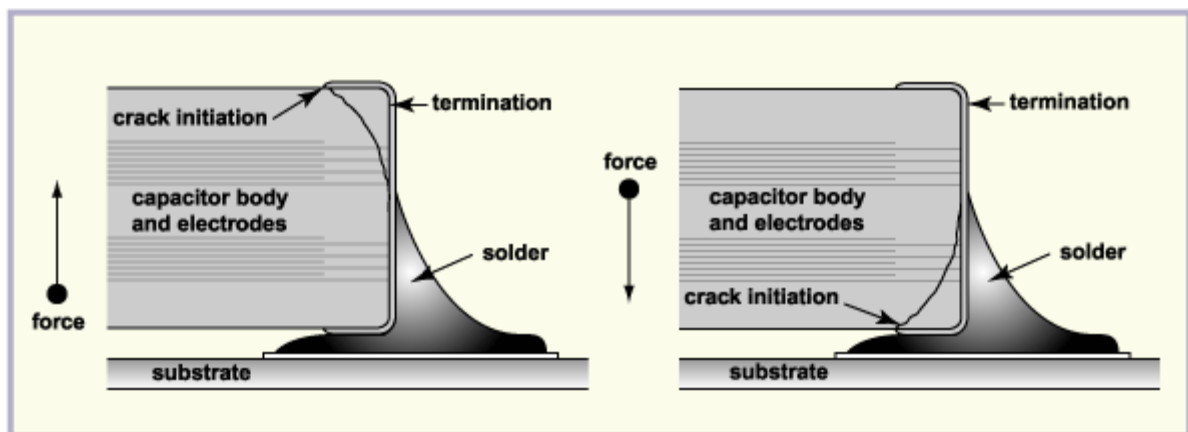
Figure 4: MLC cracking due to board stress or warpage

Cracks which are created as a result of board bending typically look quite different from thermally-induced cracks, being contained within the terminated area, as shown in Figure 4, running from the edge of the termination towards the end face of the chip.

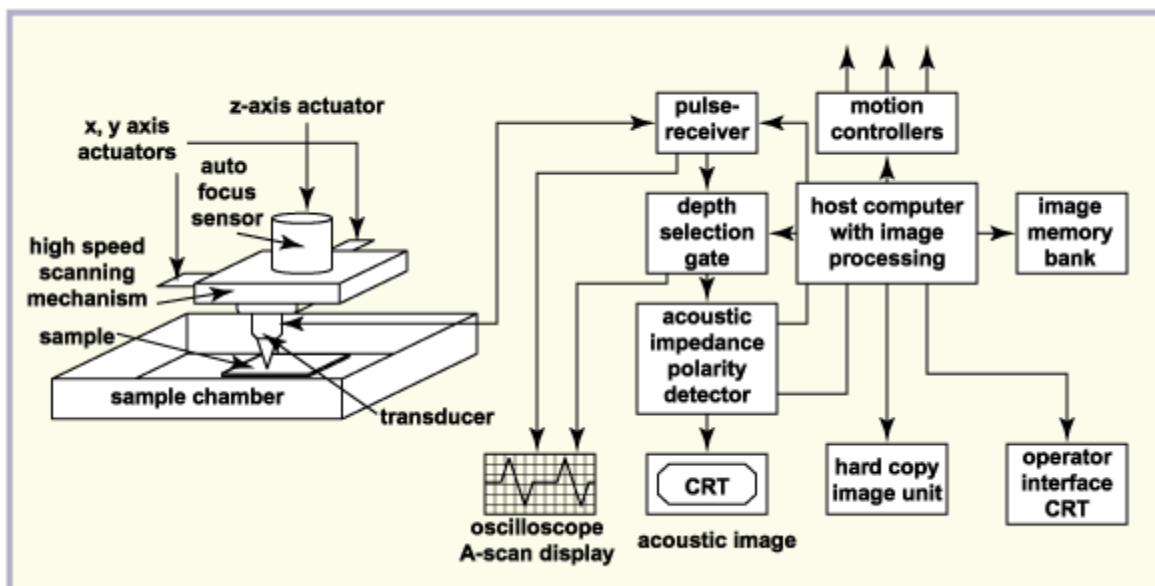
Figure 5: Schematic of C-SAM principle

An alternative (and non-destructive) method is scanning acoustic microscopy (SAM), which uses an ultrasonic transducer, typically operating at 10MHz to 100MHz, with the component immersed in fluid (usually water) to couple it to the transducer. The ultrasound travels through the material until it reaches interfaces or discontinuities, which reflect some of the energy.

- **reflection mode**, where sound reflected from the sample gives a high resolution image of the surface and near surface
- **transmission mode**, which creates contrast between areas of different density and signal attenuation, looking at the whole thickness of the sample
- **C mode** (Figure 5), designed for moderate penetration, where ultrasonic energy is focused at an appropriate plane within the sample, and the phase of the reflected wave indicates the density of the material through which it has passed.

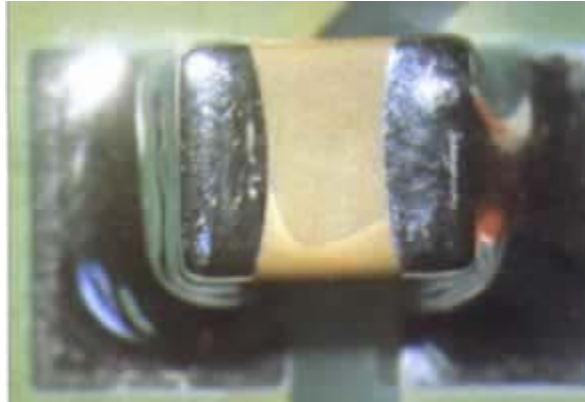
Capacitor cracking due to placement damage

- Over-pressure and/or nozzle over-travel during placement cycle: few placement machines have any direct control of the actual placement pressure
- Board sag during wave or reflow soldering, caused by poor support, followed by a subsequent straightening process (such as printing, in-circuit test or box build)

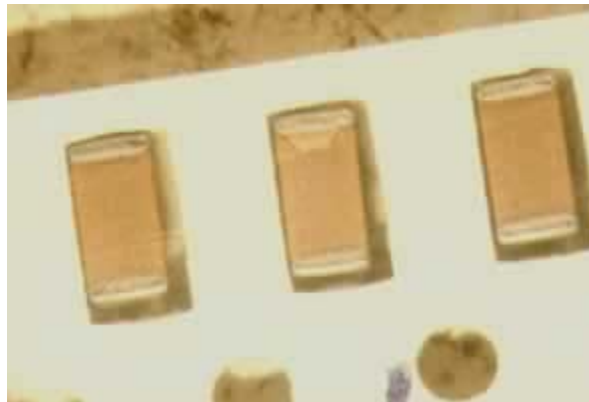
Capacitor cracked before mounting

When investigating cracking problems, it must be remembered that cracking may occur at an early stage, but only be exposed by the mechanical and temperature stresses of a later assembly process. In the past, components have even been found to be damaged before removal from their packaging!

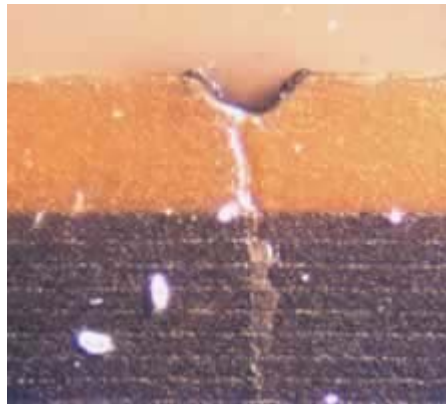
Capacitor damage due to excessive laser marking

When you investigate failures, you should always expect the unexpected. Chip ceramic capacitors are usually unmarked, because of the practical problems of doing this. However, some end customers, particularly in the automotive industry, prefer capacitors to be marked, so that they can have visual assurance that the correct component has been fitted. Given the small dimensions of the components, the most obvious method for marking is to use a laser to 'write' on the ceramic surface. Provided that this is carried out with appropriate power levels, this coding is effective and not damaging. However, if too high a power setting is chosen, then the laser coding can generate cracking down into the sensitive dielectric area. As we explained earlier, cracks are always bad news!
