# Solving the ENIG Black Pad Problem: An ITRI Report on Round 2

F.D.Bruce Houghton  
Celestica, Inc.  
North York, Ontario, Canada

## Abstract

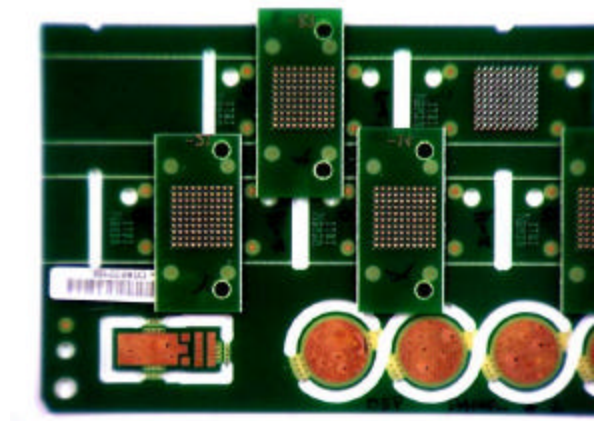
**Figure 10 – TV with Partial Assembly**

For both Round 1 and 2, in order to create a BGA component, a solder ball had to be made on the 'component' side of the package. The use of preformed solder balls was considered, but the assemblers for Round 1 and 2 did not have the capacity or capability at the time. It was decided that the solder balls would be made on the 'component' side of the mini panels by screen pasting a large volume of eutectic solder paste and then reflowing the paste. This would entail using a thick stencil with a large aperture. The same assembly process and stencil will be used for Round 2 and was used for Round 1. However, Xetel will do the assembly for Round 2. See the report on Round 1 for more details on the process [2].

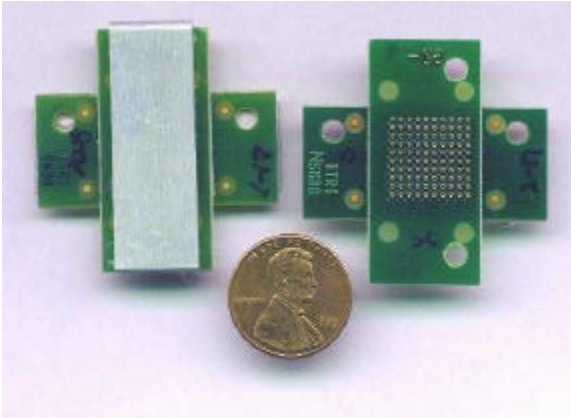
**Figure 13 – TV Coupons Ready for Stress Test**

Aluminum stiffeners approximately 0.125" thick, 0.50" wide and 1.5" long will be epoxied to each side of each BGA coupon to prevent the BGA coupons from bending during the Instron pulling, the same as Round 1. During Round 1, we aimed for at least 7 good Instron pulls per cell. During Round 2, we are aiming for 10 good Instron pulls per cell, for a higher degree of confidence in the results. This data will then have to be analyzed back against the test matrix.
